Guidelines for
**Preservation, Stewardship
& Development**

Guidelines for the
Preservation, Stewardship, and Development
of the
Dimock Community Health Center Campus
55 Dimock Street
Roxbury, Massachusetts

Prepared by August Associates, Architects
under contract with
Historic Boston Incorporated
with partial financial support through the
Boston Landmarks Commission
from the City of Boston
Neighborhood Development and Employment Agency
Community Development Block Grant funds.

November 1984

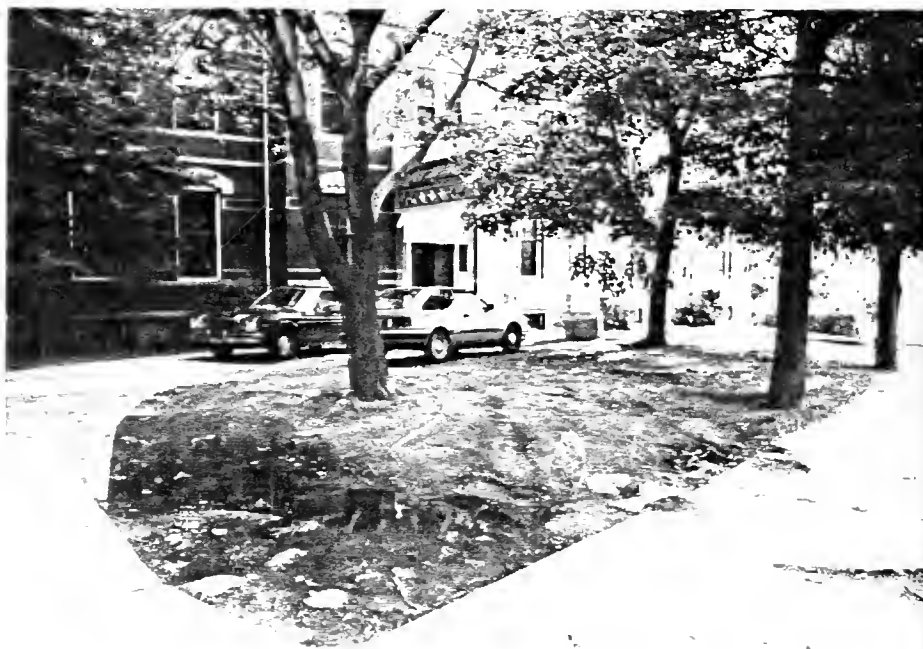
112

This building has a nice entrance which could be greatly improved with proper maintenance and restricted parking.

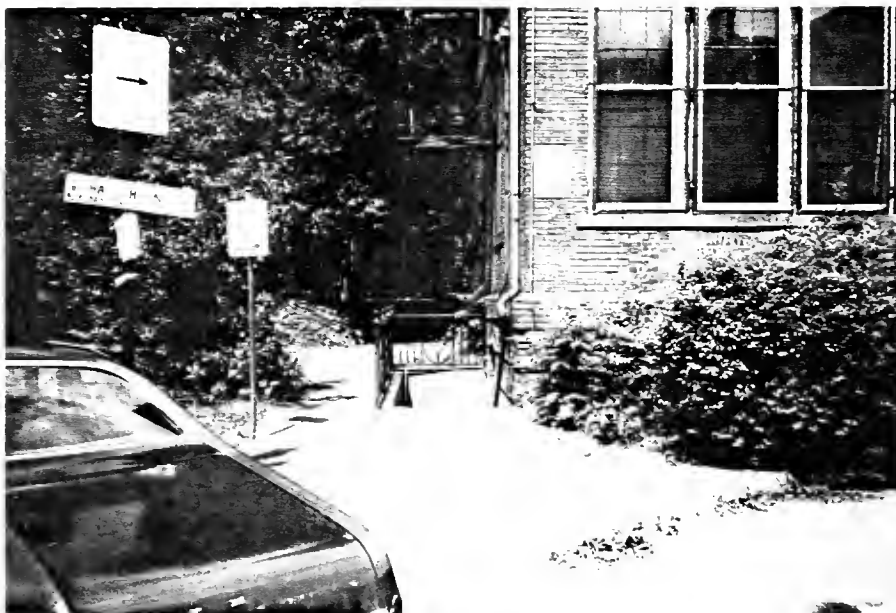
115

The entrance to the Hawthorne Center, passing by the basement entrance, is not well situated.

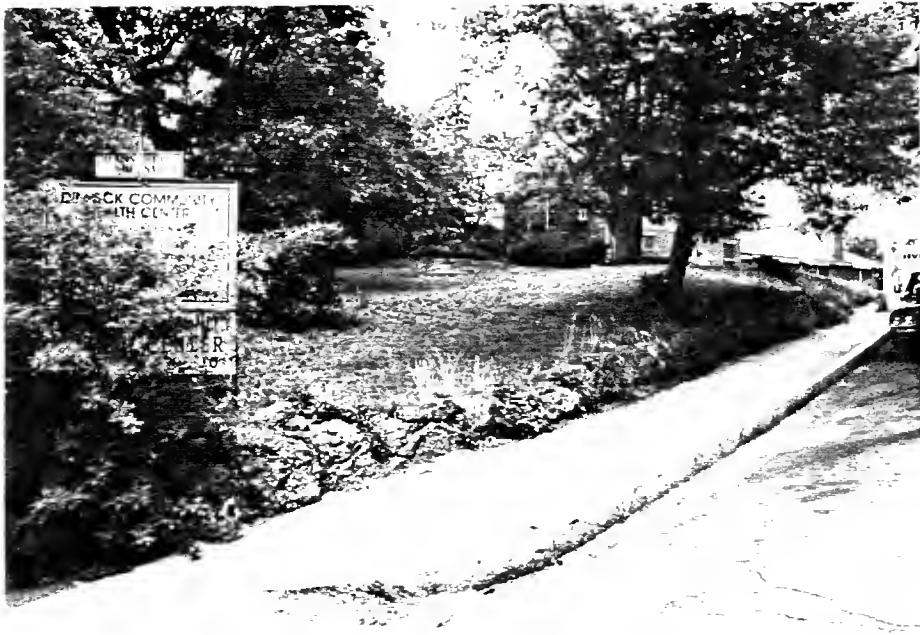
117

Nice view across the campus. Bad sign placement.

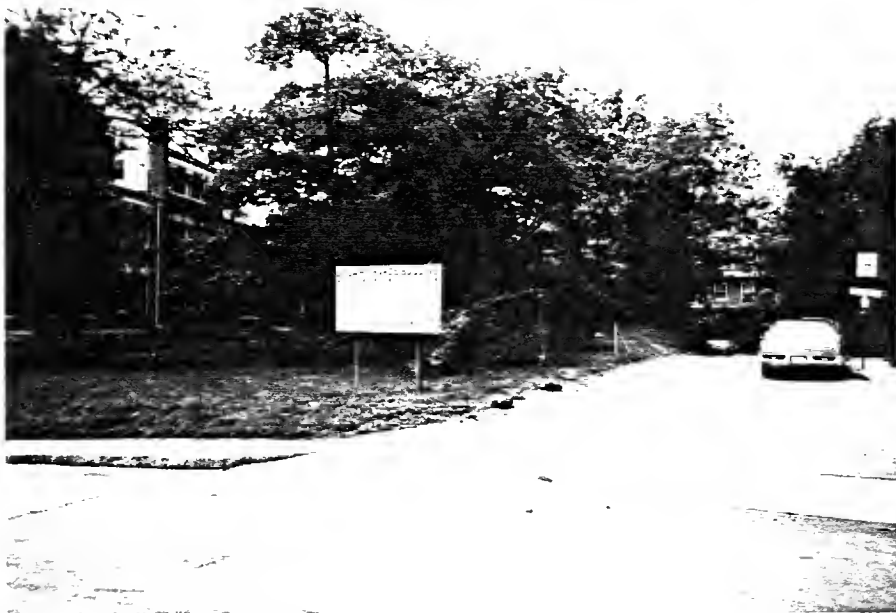
118

Richards sign should be incorporated into the outcrop.

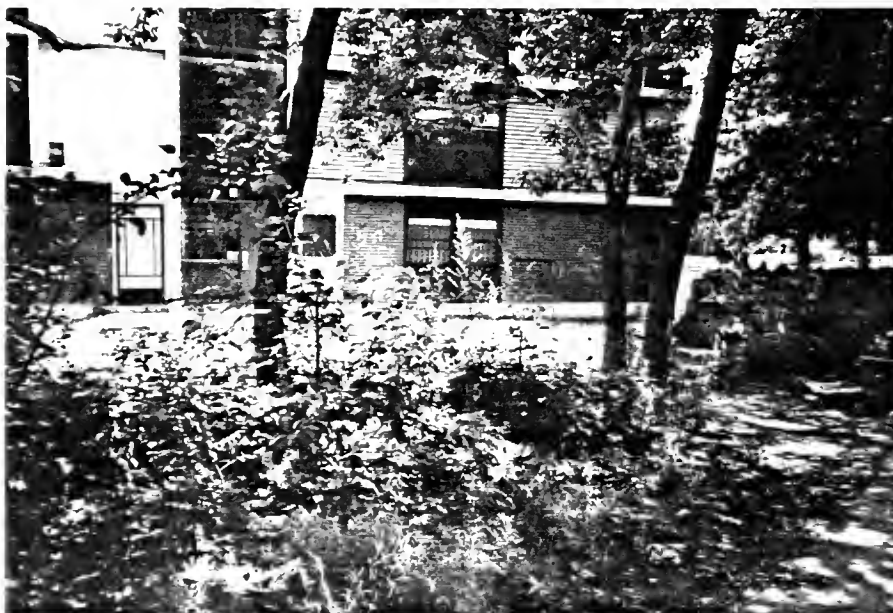
120

The wall needs to be continued to a logical end. If an opening to the apartments is desired, it should be a proper gate.

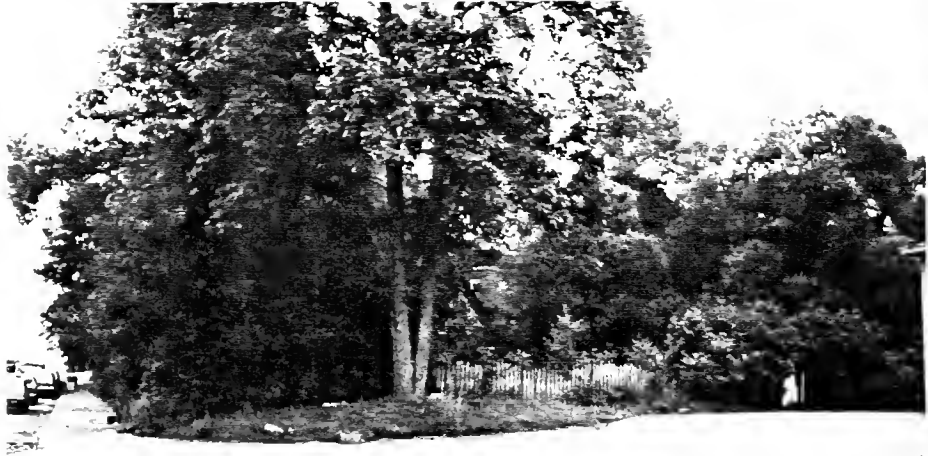
123

Columbus Avenue fence
along south property
line.

Plants growing through
the fence should be
removed.

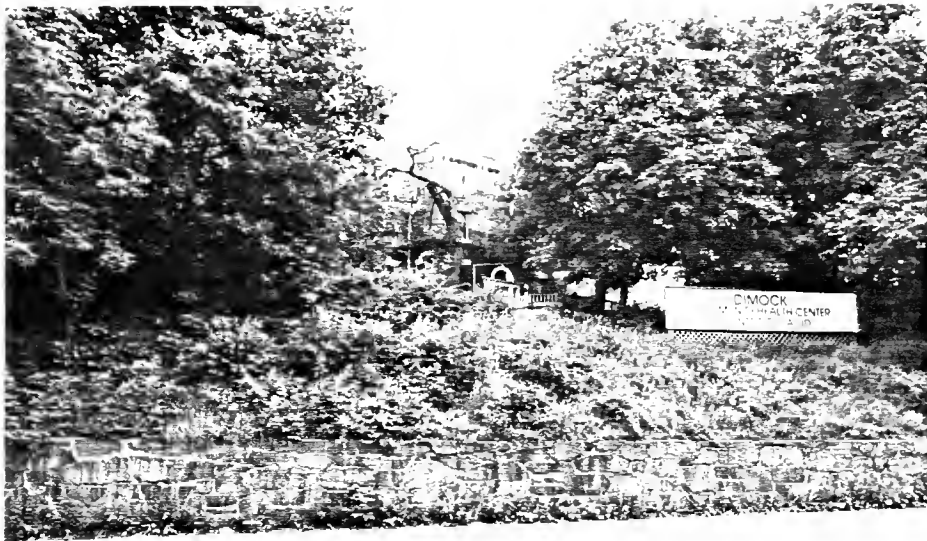
125

The billboard sign should be removed. The stone retaining wall needs tuck-pointing. The view to the Cheney entrance is good.

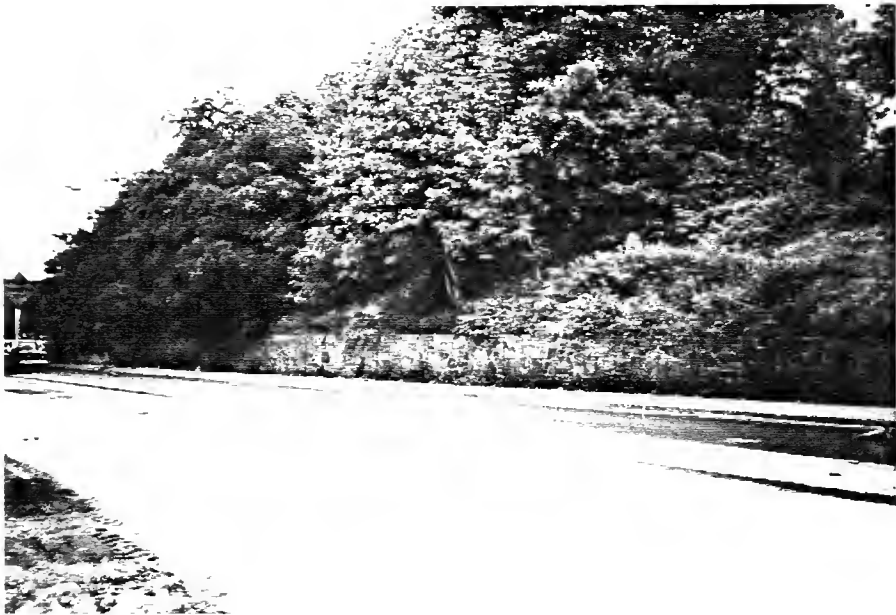
126

The important grade change and dense planting along Columbus Avenue should not be disturbed.

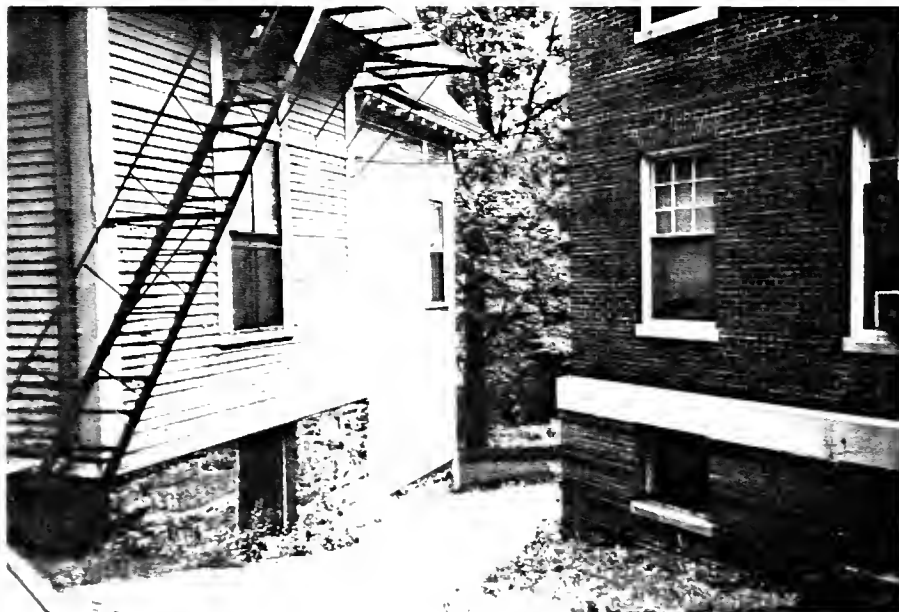
127

Access between the buildings from a lower parking area need to be developed.

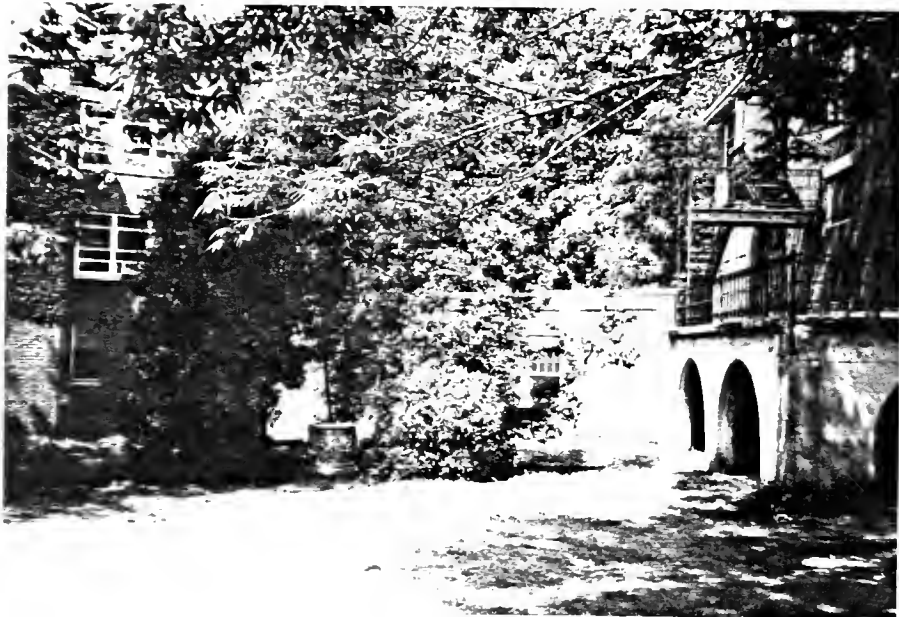
128

Nice landscape garden feature. Needs to be cleaned up and pruned.

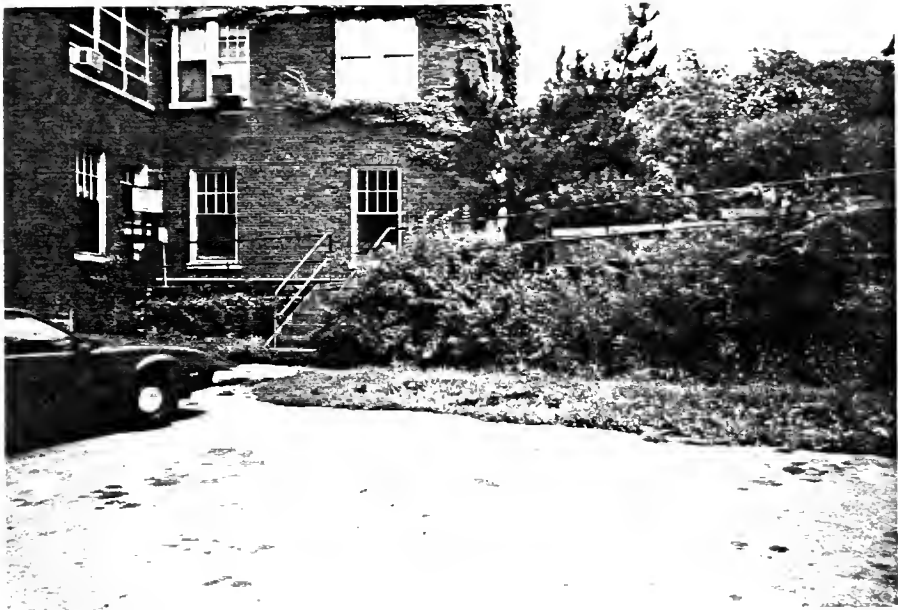
129

The planting of dog-woods, almonds, crabs and/or redbuds along the walkway would soften the parking edge and add interest to the walkway

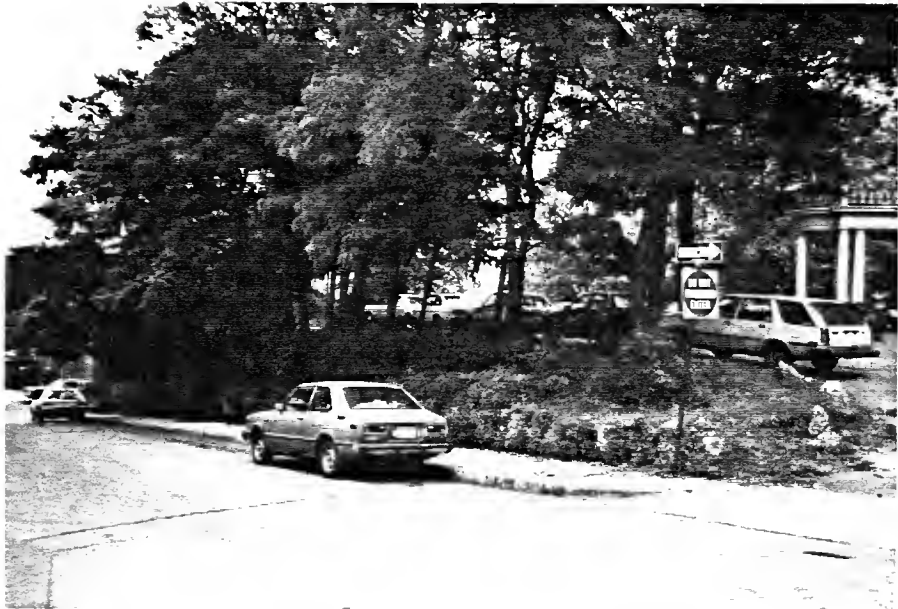
130

Important grade change, additional planting needed to screen cars. Consider arching street trees.

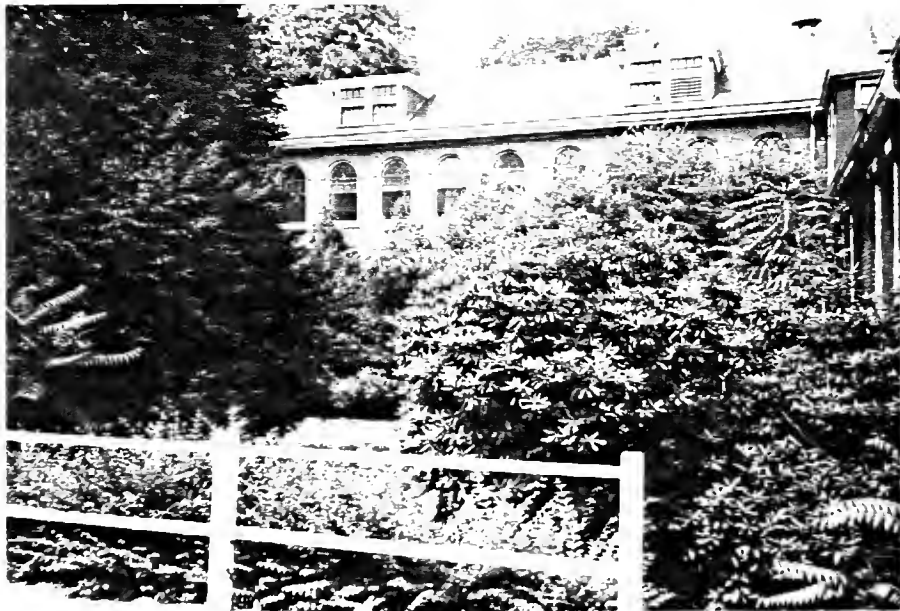
131

The entrance to the Sewall courtyard is obstructed by mature rhododendron.

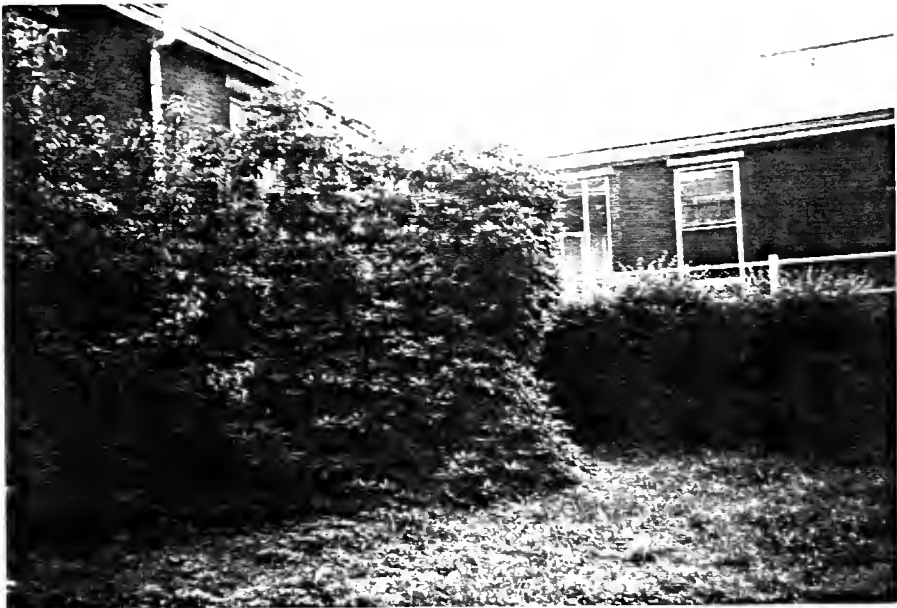
133

Views into the courtyard are blocked by overgrown plants.

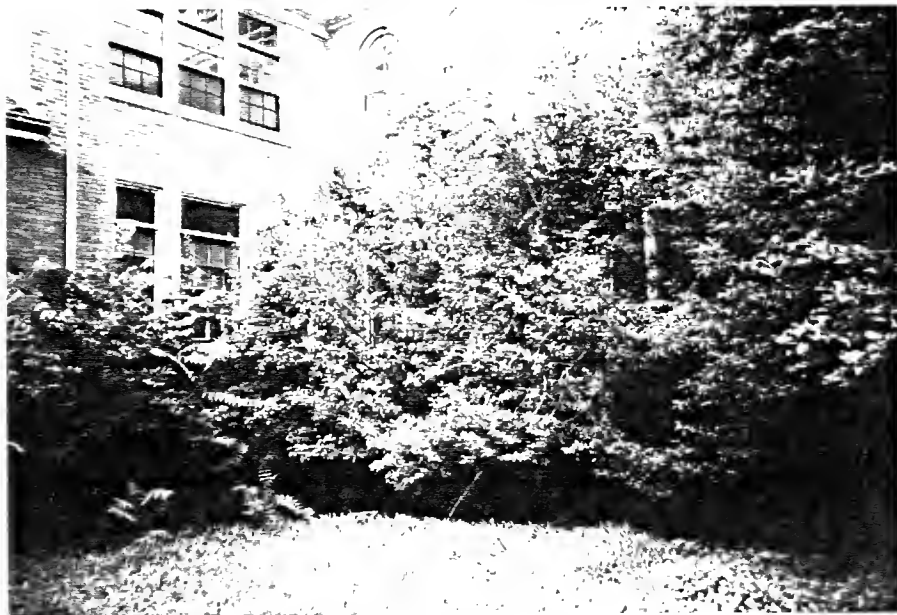
134

Thin crabtrees screening arched windows.

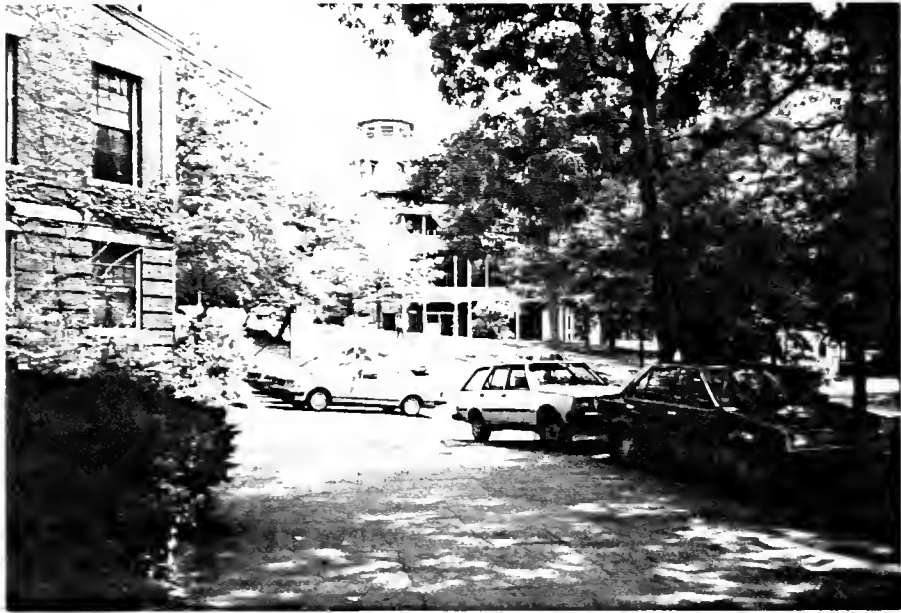
135

Too many cars in the
wrong place. This
should be the entrance
to Cheney.

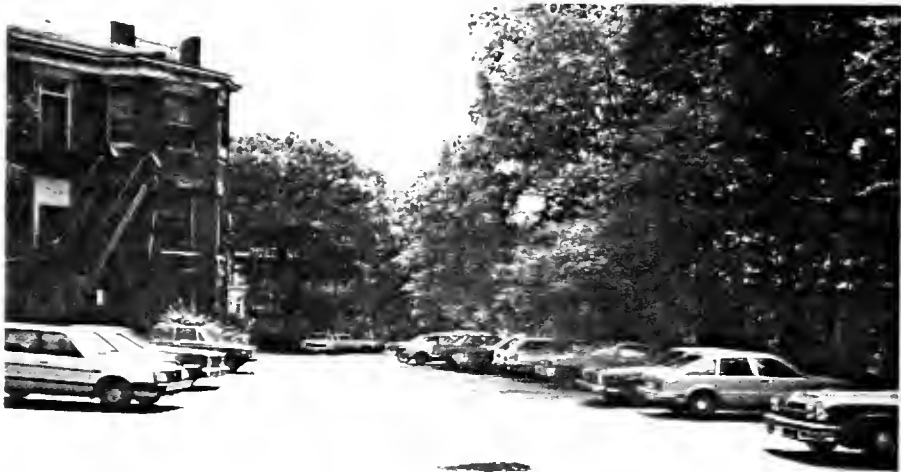
136

Inefficient use of
parking lot.

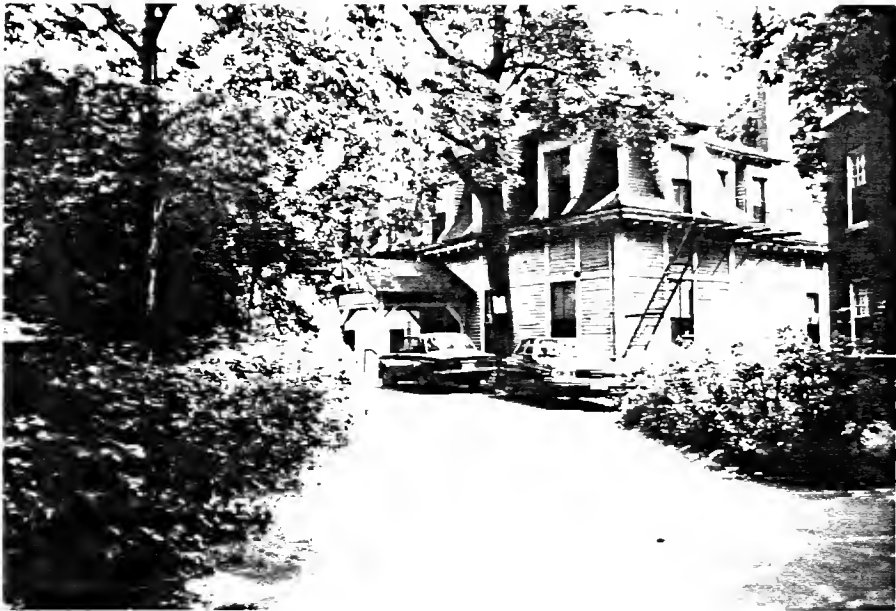
137

Cars parked in the
wrong place.

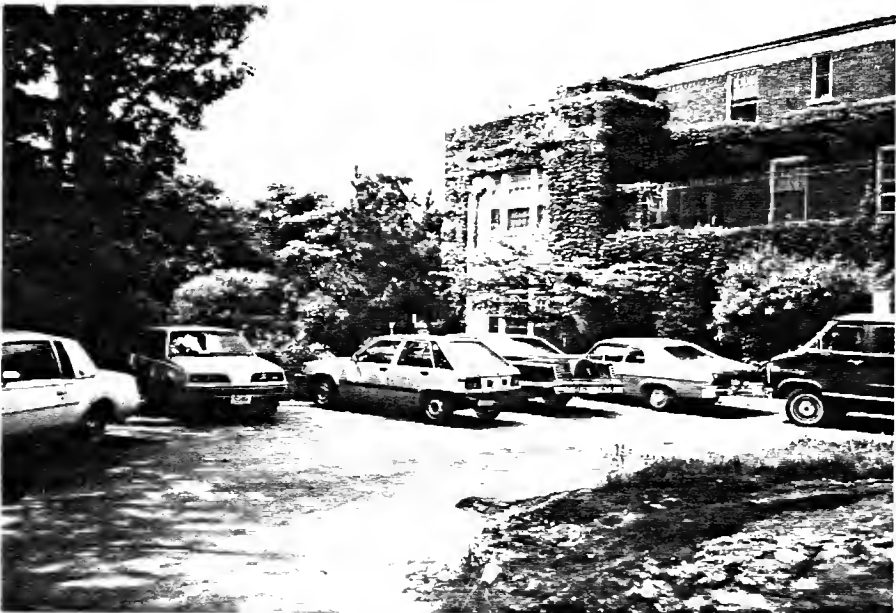
138

Short term parking
could be provided for
here. Present use is
haphazard.

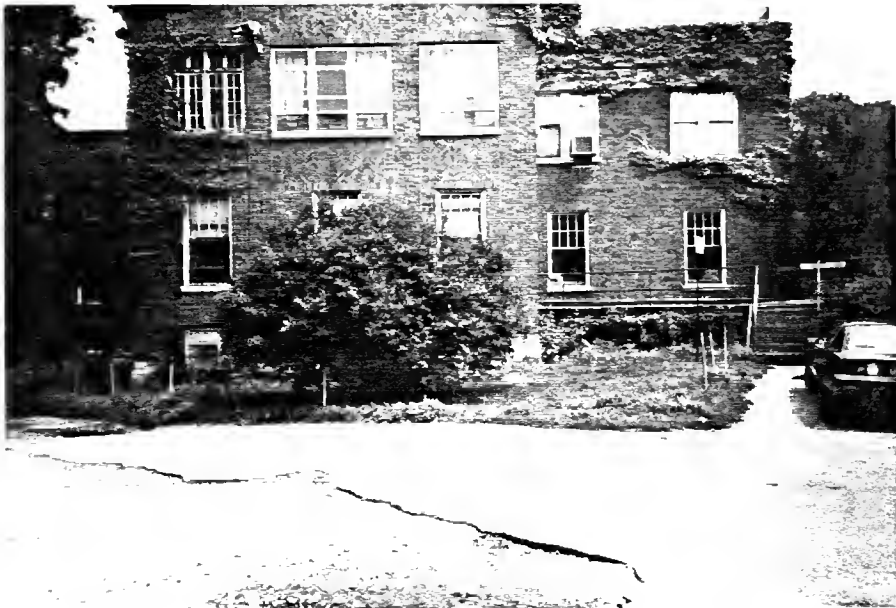
141

Road surfaces, edging,
and fencing combine to
give an unkempt appear-
ance.

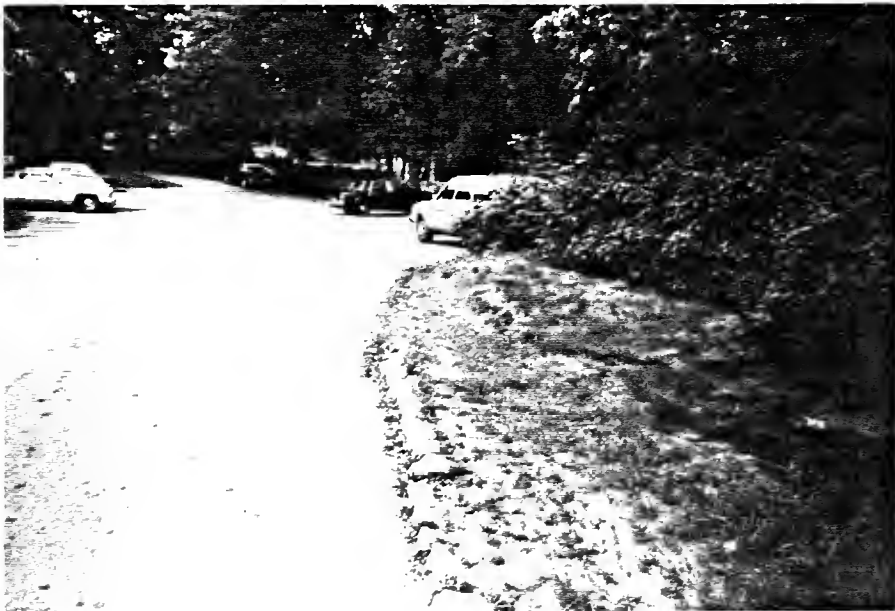
142

Nice materials, cob-
bles, needs maintaining
to realize potential.

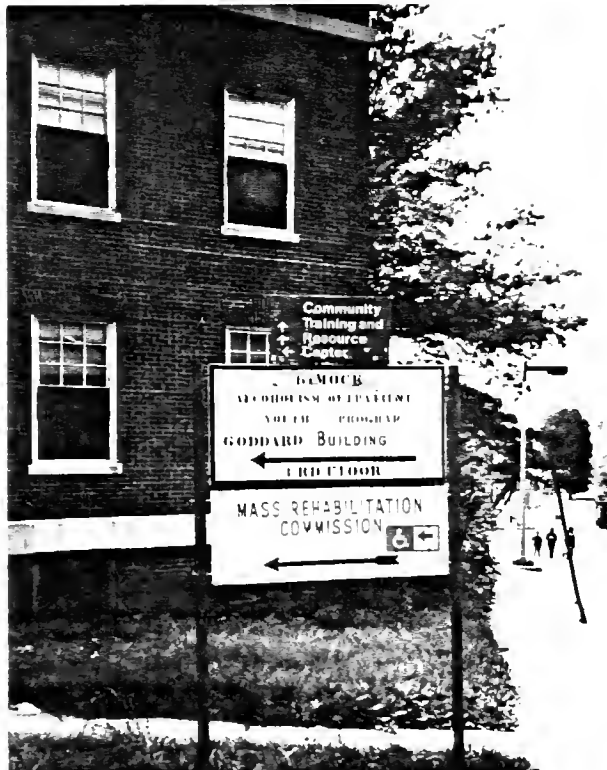
143

Obvious maintenance
needs to be attended
to.

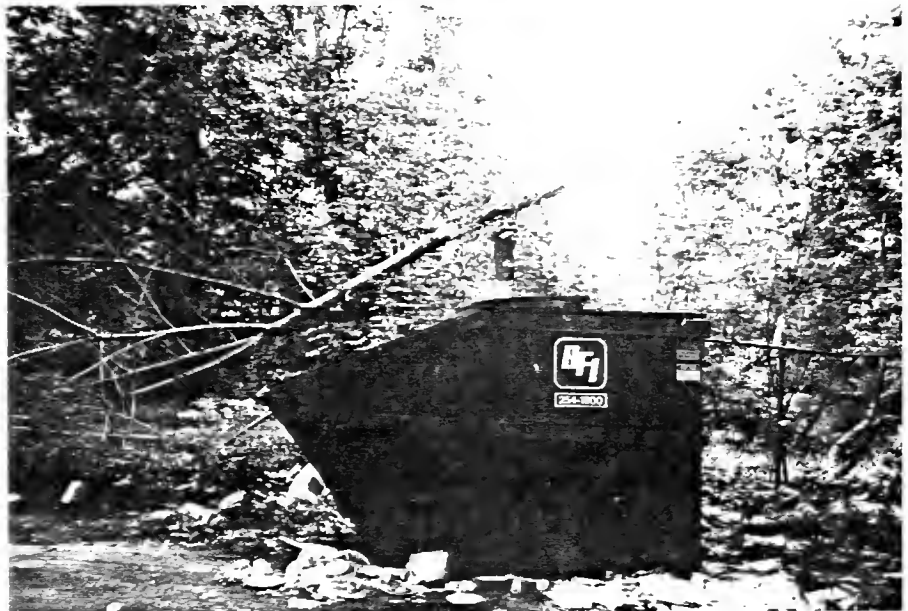
144

Obvious maintenance.
